East Wynyard Seabrook Beach

Sunday 20th March 2022

Current Erosion Situation

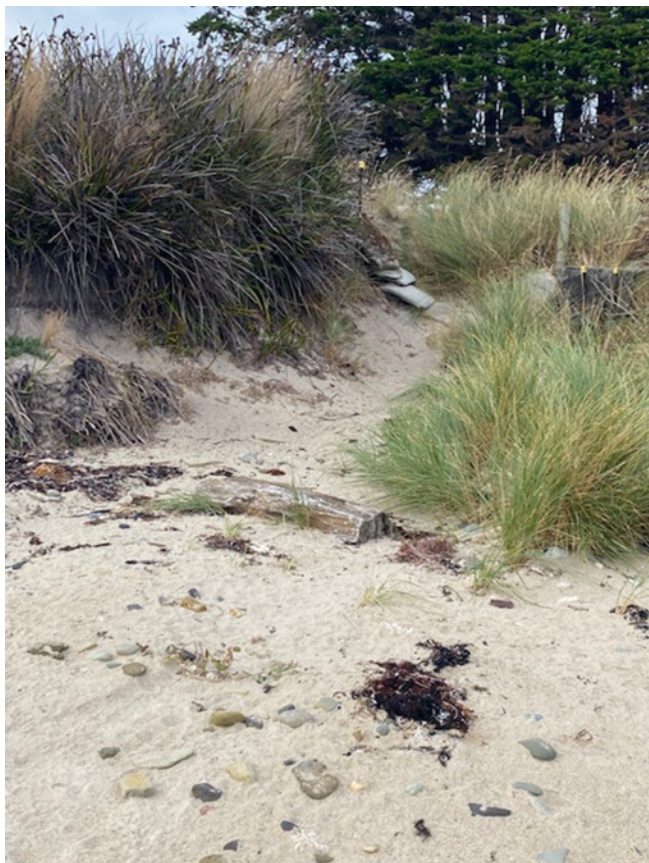
Photo 1 – Drain Near Gate 1 2022

- From 2005 to 2022 erosion near gate 1 has been significant. In 2005, distance from beach to penguin fence was about 8 metres. Photos 1 & 3 show that this is now about 3 metres. Photo 2 from gate 2 shows the distance from beach to penguin fence is still about 8 metres. Erosion is highest at the Eastern end of the beach.
- At least once a year a king high tide wipes away all the face of the beach bank and shrubbery, with many penguin burrows washed away. Photo 4 shows original shrubbery. Photo 5 shows wash away after a king tide.
- Photos 5 and 6 show the dying off of shrubbery and the diminishing of the penguin habitat as high tides encroach killing the trees.

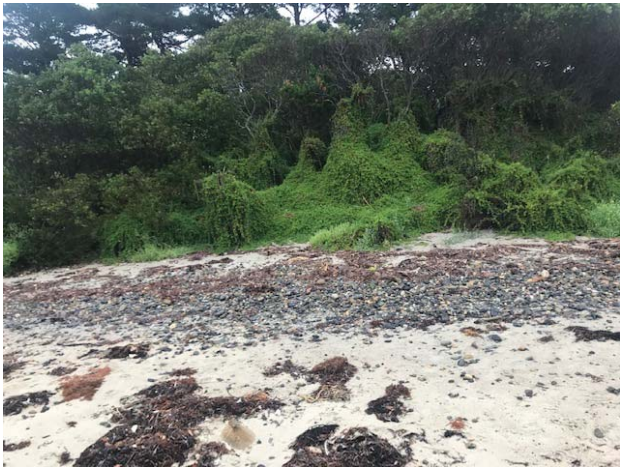
Photo 4 - Midway between Gates 1 and 2 2020

The Penguin Habitat from Gates 1 to 3 is unstable.
