Fitzgerald Frisby Landscape Architecture, along with subconsultants Rare Innovation (structural engineering) and Cultural Heritage Management Australia (cultural heritage) has been engaged by Waratah-Wynyard Council to undertake an Options Study of the Inglis River Walking Track.

The Track meanders through the riparian reserve of the Inglis River from the bridge crossing at the Bass Highway through to the river mouth and provides a recreational connection between Gutteridge Gardens and Fossil Bluff. Over time a number of timber structures and hardened paths have been constructed through this walkway to support its use and growth. Some of these structures are now at the end of their useful lives and require replacement with replacement cost estimated by Council to be approximately \$1.8m. In 2011 and 2016 significant flood damage was incurred to the walking track infrastructure as well as noticeable erosion and loss of some of the riverbank.

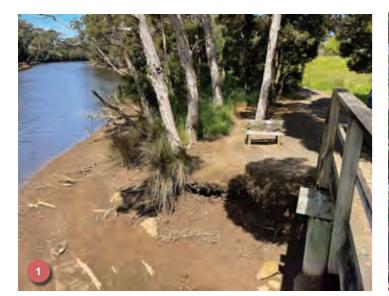
Image: Erosion at the mouth of Big Creek.

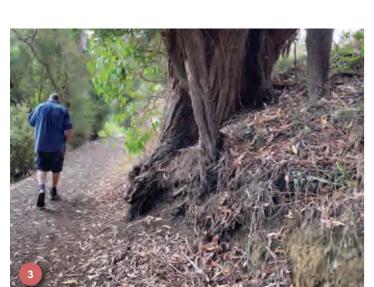
Image: High side of the Track showing erosion, south bank between Bass Hwy and Crowes Bend

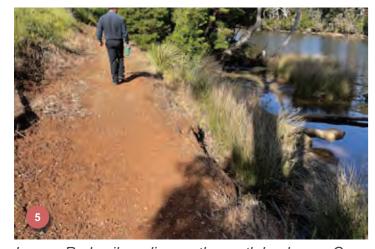
Image: Red soil eroding on the north bank near Cape Bridge

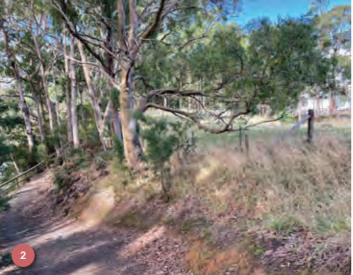
Image: Erosion on upper side of path, south bank between Bass Hwy and York St Reserve

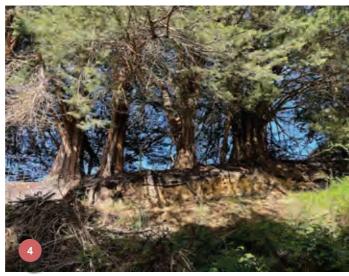
Image: Macrocarpa roots holding soil along the boundary of the river corridor, north bank

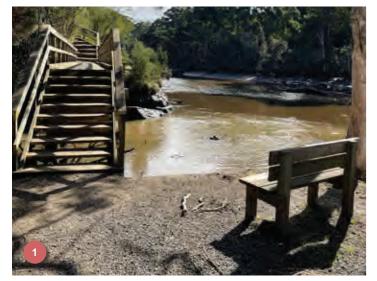
Image: The seating area at Big Creek is submerged at king tide, with water reaching the bottom step of the bridge.

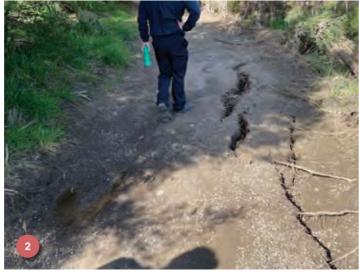
Image: Deep cracks in the regularly inundated area near Crowes Bend

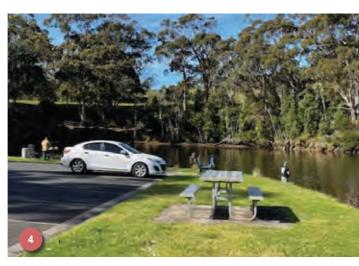
Image: Much of the Cape Bridge Picnic Area is given over to roadway and car park, pushing recreational activities to the low-lying edges.

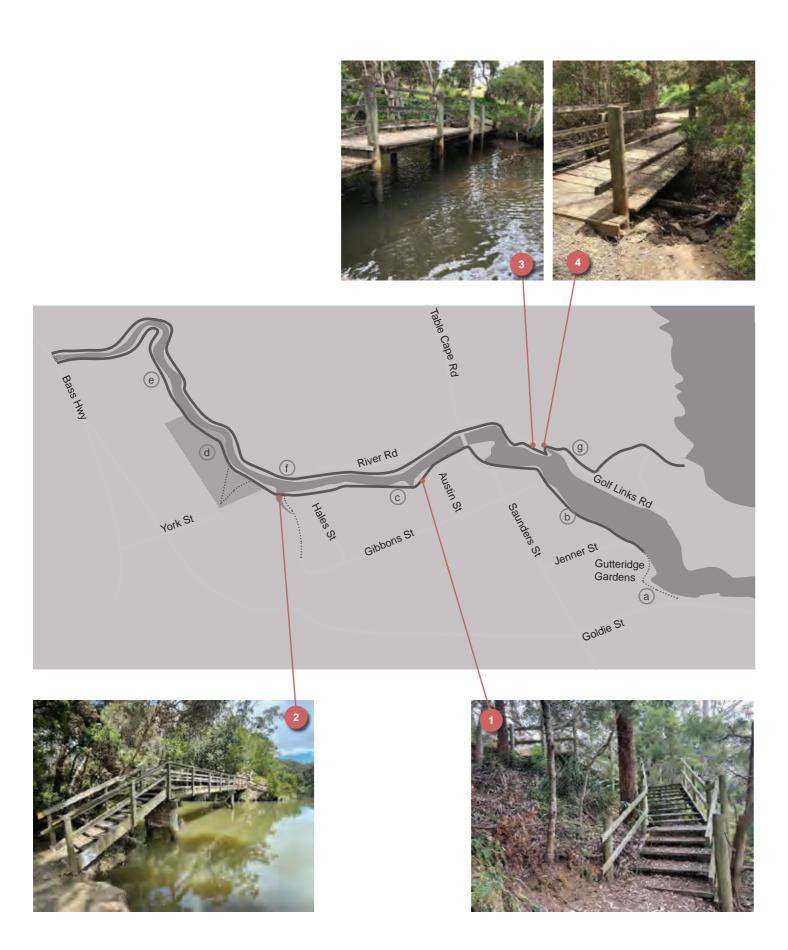
The structural elements identified as being 'at end of design life' (requiring replacement in the next year to two years) were (refer to adjacent plan):

- (1) **WWC list no. 139.** Ramp from road level leading into a flight of timber stairs toward the river. Stairs terminate on the river-side close to riverbank height. Recommend replacement/renewal within 1 year from time of assessment.
- (2) **WWC list no. 141.** Multi-span timber bridge over significant river inlet with multiple braced piers. Soil obscuring view of abutments at Western end. Recommend replacement/renewal within 2 years from time of assessment.
- (3) **WWC list no. 150.** Significant timber bridge structure crossing approximately 25m water. Central 10m is raised by a stair level. Recommend immediate replacement/renewal.
- (4) **WWC list no. 151.** Approximately 10m timber bridge structure of smaller river inlet, at the time of inspection a low amount of water below the deck. Recommend immediate replacement/renewal.

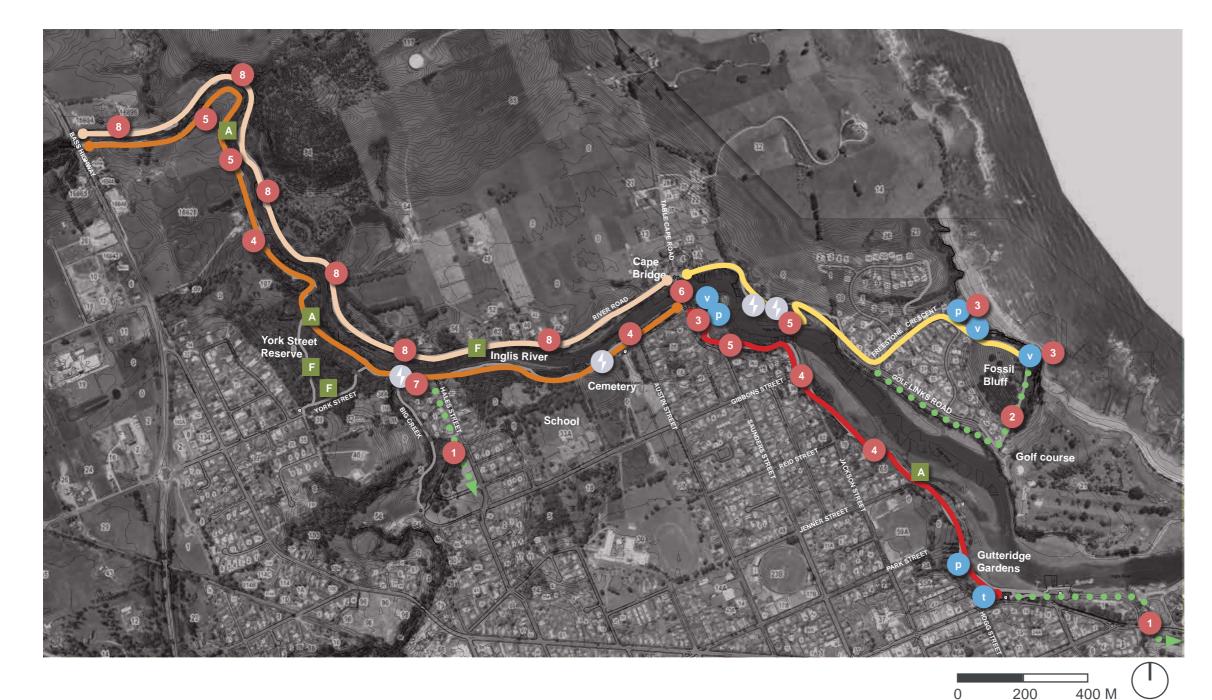
Issues and opportunities plan

- Potential to link with trail along Camp Creek.
- Opportunity to realign the Track out of residential streets up the south side of Fossil Bluff.
- Opportunity to improve accessibility of destination points by adding public toilets and improving existing picnic facilities and pedestrian infrastructure.

- Potential to realign Track away from unstable edges.
- Potential to realign Track up the bank to avoid inundation/requirement for boardwalk and reduce impact on sensitive environments.

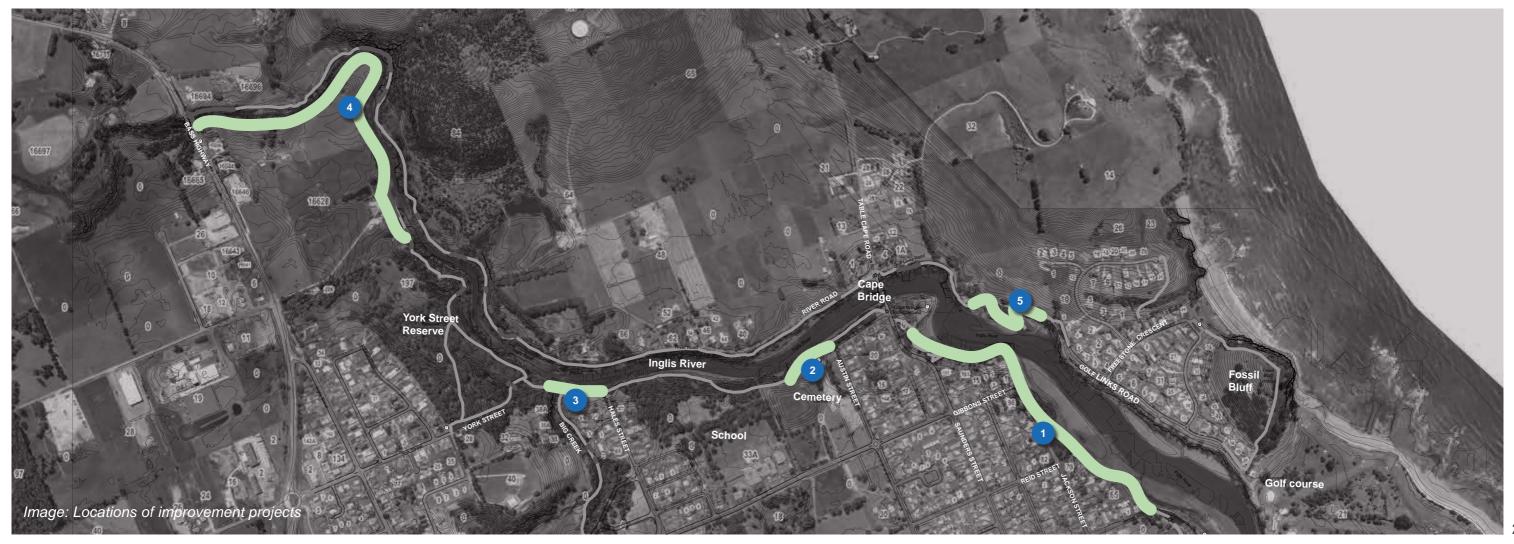
Track improvement project 1 - Boat Ramp to Picnic Ground (sheet 1 of 2)

Proposed realignment Realigned path away from risk zone and sensitive vegetation. Connect to existing path through trees. Refer to Typical New Path Details. **Sensitive vegetation** Existing patch of paperbarks to be retained and protected. Inglis River **LEGEND** Title Boundary Existing Inglis River Trail alignment **Existing steep culvert Existing trees** Existing patch of Eucalyptus sp. Provide balustrade and make Existing trail structure good to replace lost manhole and to be retained and protected Existing path/structure to be demolished and revegetated/made embankment zone **Existing lower path** Demolish and revegetate Proposed trail alignment Proposed trail structure Risk zone (sea level rise) Risk zone (storm tide encroachment) Risk zone (coastal erosion hazard Existing trail entrance **Existing path** connections Retain **Existing risk zone** Potential future **Proposed realignment** realignment or structure Realign path away from steep required to manage risk edge and reduce encraochment to existing native vegetation. Refer to Typical New Path Details. **Existing boardwalk** Demolish and revegetate area
