PLANNING PERMIT APPLICATION
APPLICATION FOR PLANNING APPROVAL UNDER SECTION 51,
LAND USE PLANNING & APPROVALS ACT 1993

Demolition of existing dwelling, replacement dwelling and construction of retaining walls.

**ADDITIONAL INFORMATION REQUIRED
DEVELOPMENT APPLICATION – Demolition of existing dwelling,
replacement dwelling and retaining walls
15 Hepples Road and 13 Hepples Road BOAT HARBOUR BEACH**

Planning approval is sought to demolish an existing dwelling and construct a new dwelling and retaining walls on land located at 13 and 15 Hepples Road, Boat Harbour (the site - refer to Figure 1). This planning submission provides relevant details of the application and an assessment against the applicable provisions of the Waratah-Wynyard Interim Planning Scheme 2013 (the Scheme).

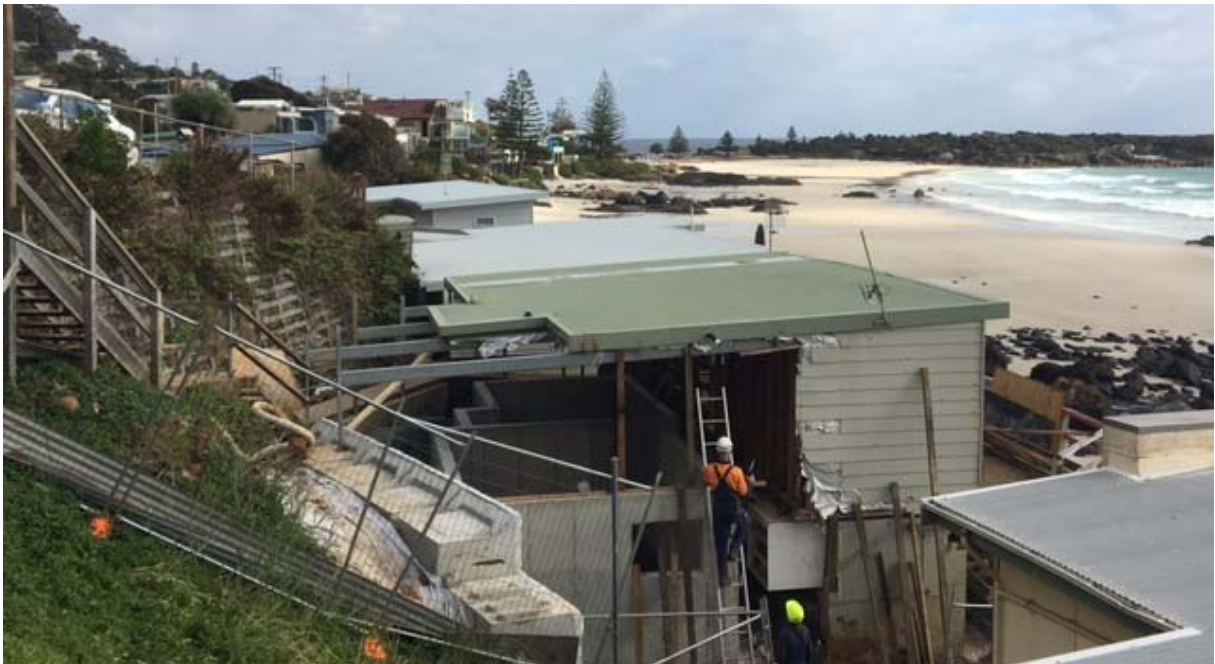
Figure 2 - photograph showing the extent of partial demolition of the existing dwelling and construction of the new dwelling that has already occurred.

Aspects of the proposed development have been carried out without obtaining relevant planning and building approvals which include partial demolition of the existing dwelling, partial construction of the new dwelling and construction of the two new retaining walls (refer to Figures 2 and 3). Retrospective planning approval is therefore sought for development that has occurred without obtaining the necessary planning approvals.

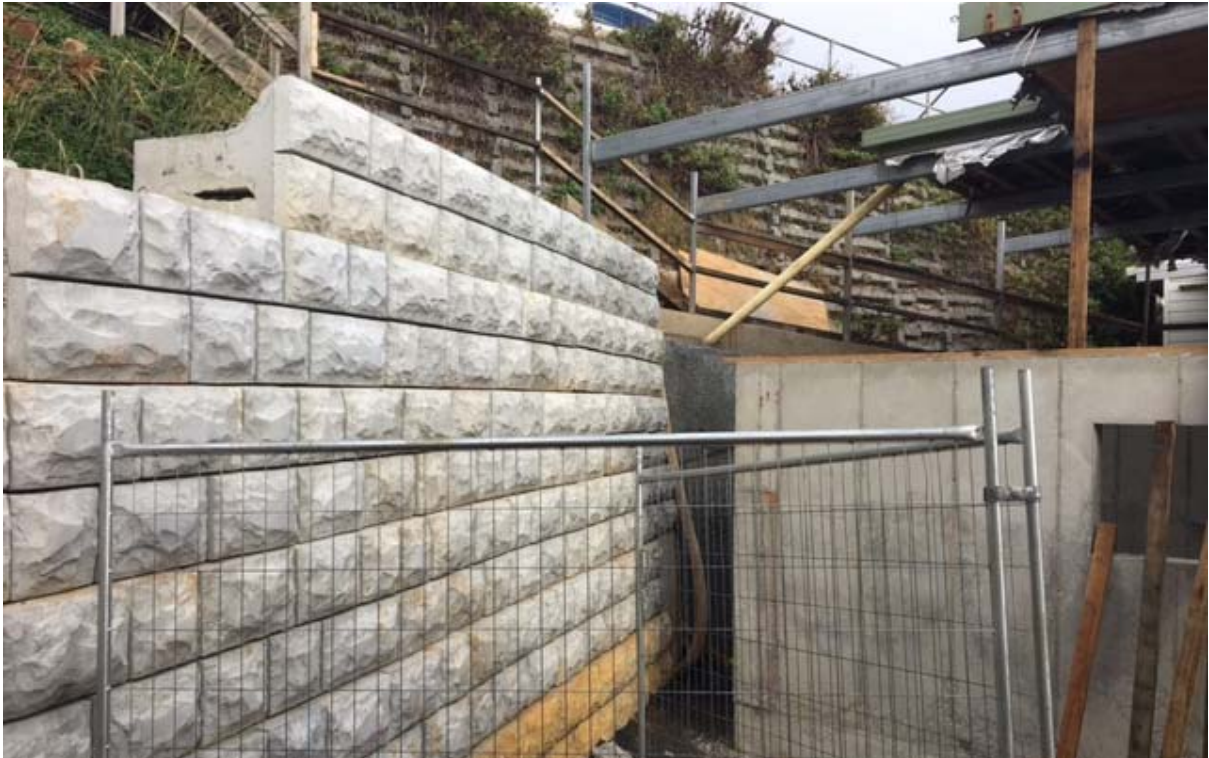
Figure 3 - photograph showing the as constructed 'verti-block' retaining wall.

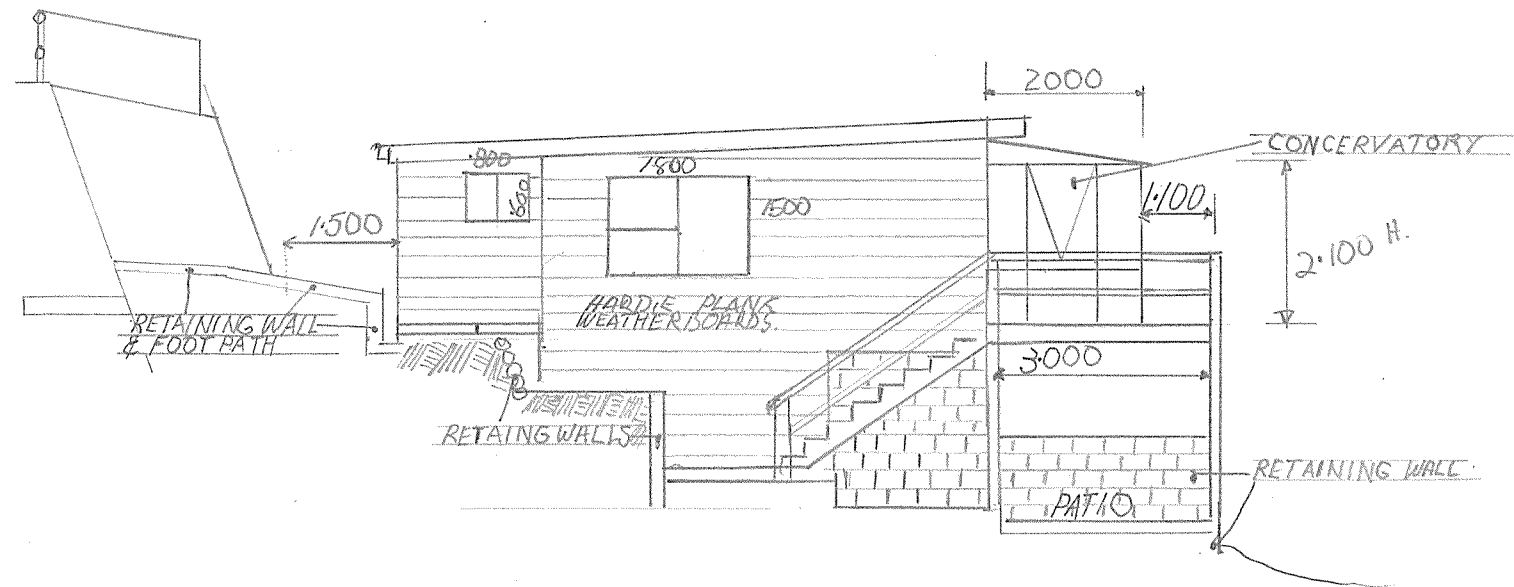
EASTERN ELEV.

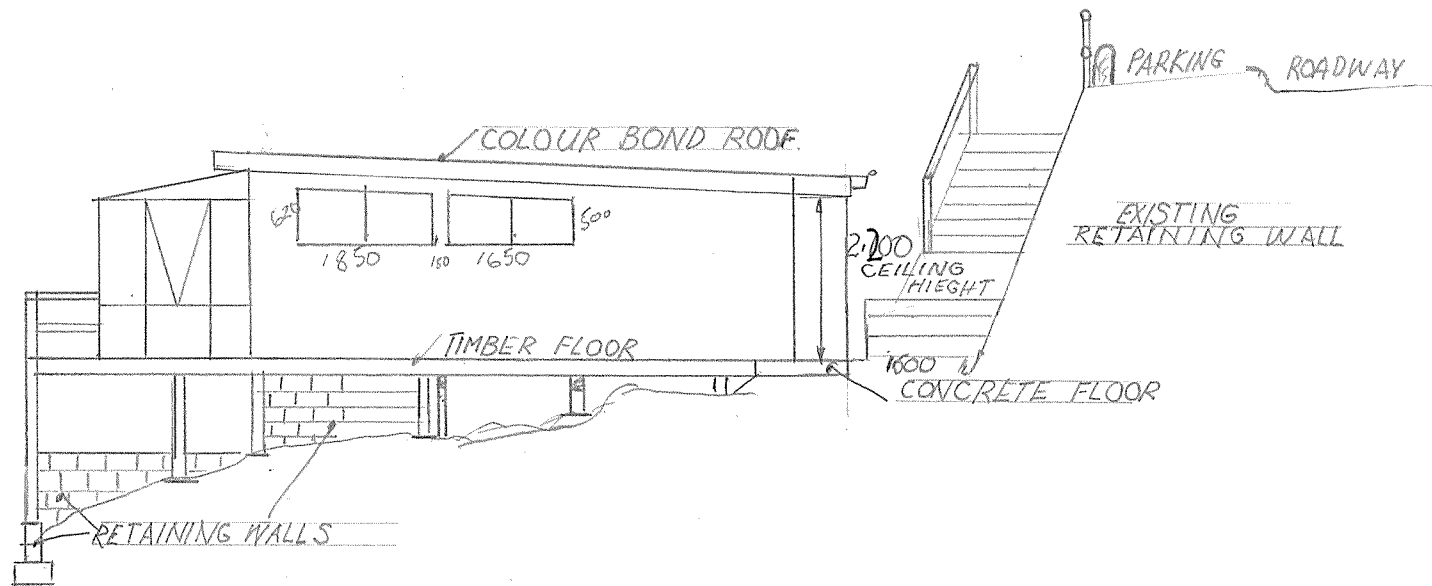
WESTERN ELEV.

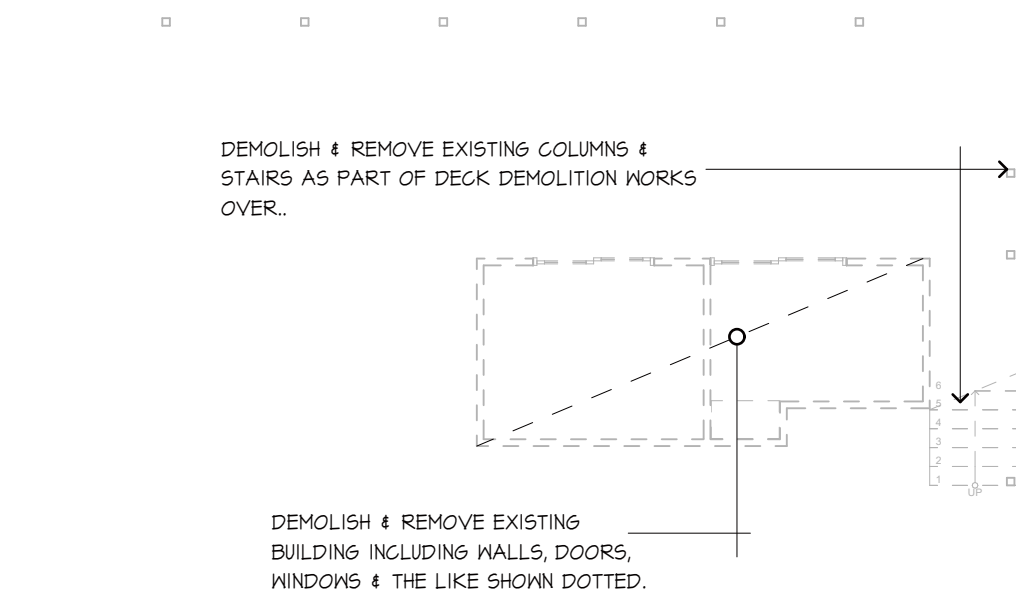
PROPOSED GROUND FLOOR DEMOLITION PLAN
SCALE 1:100

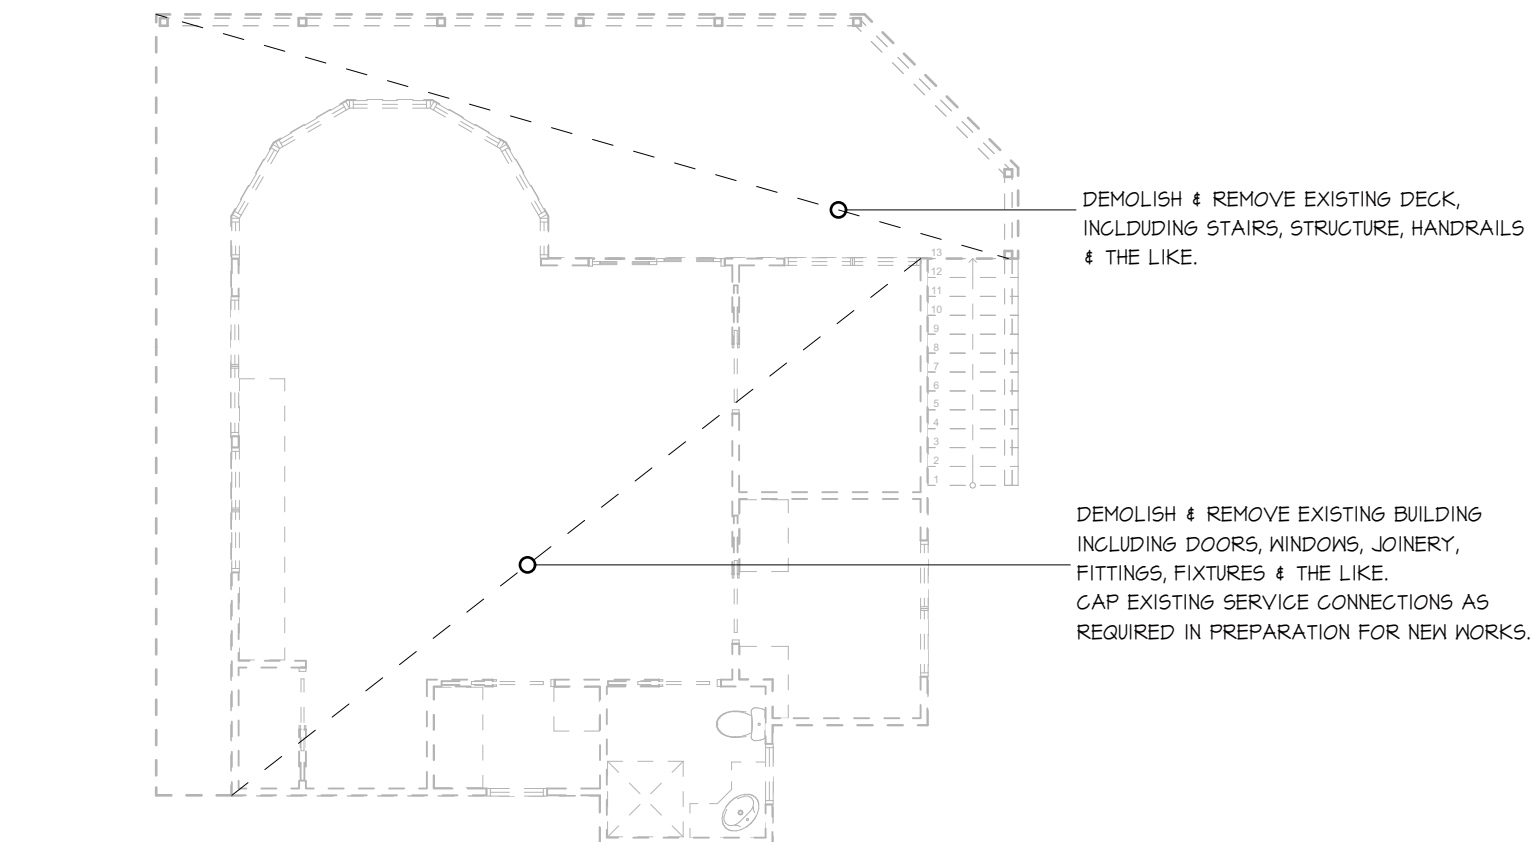
PROPOSED FIRST FLOOR DEMOLITION PLAN
SCALE 1:100

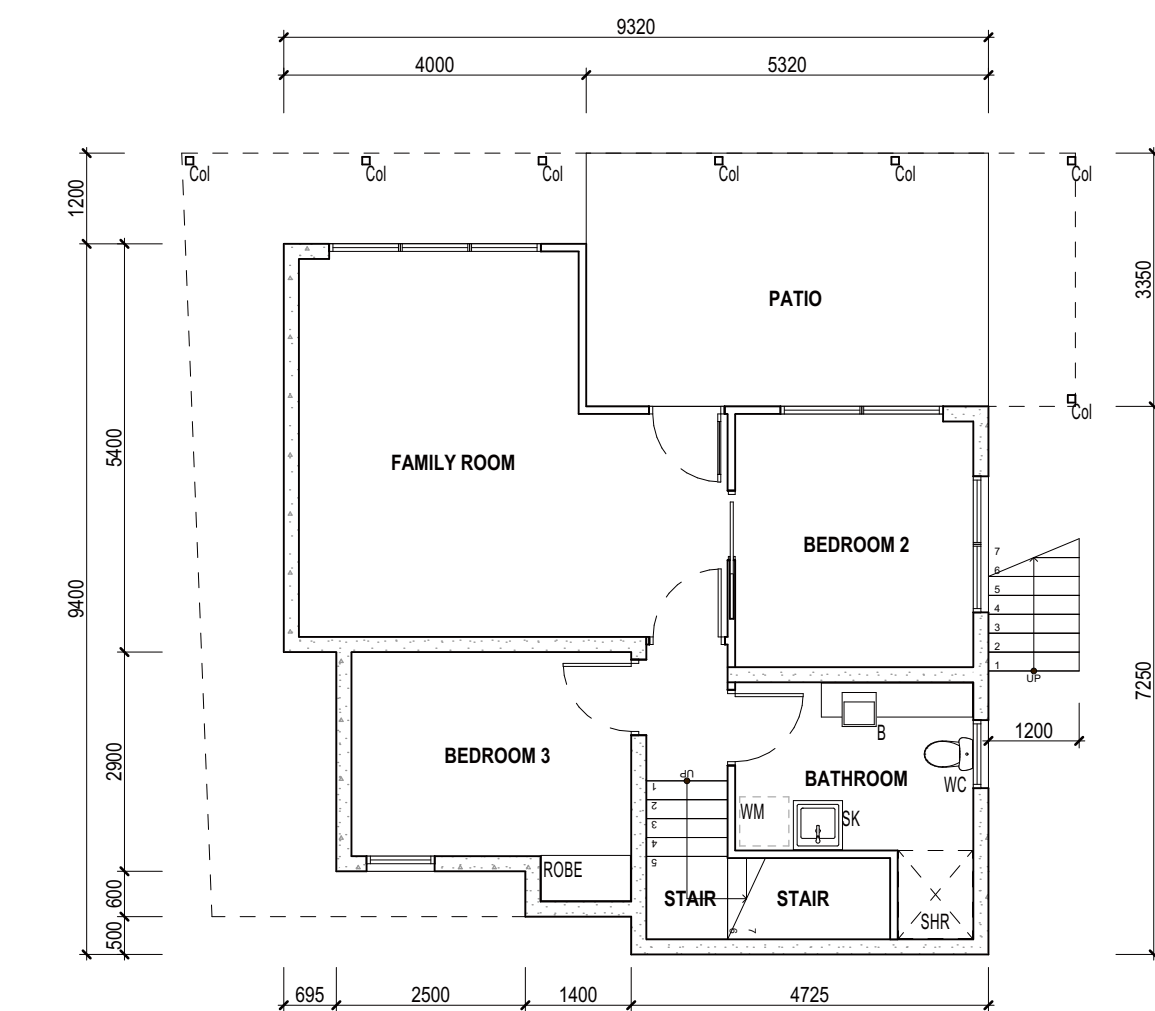
PROPOSED FLOOR PLAN
SCALE 1:100

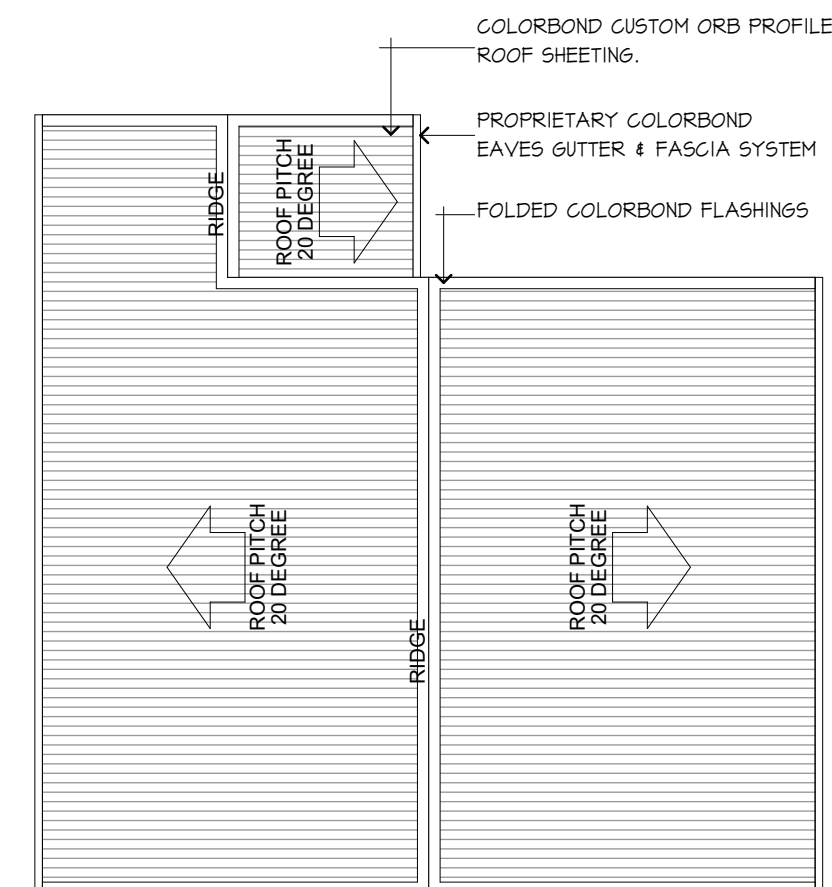
PROPOSED ROOF PLAN
SCALE 1:100

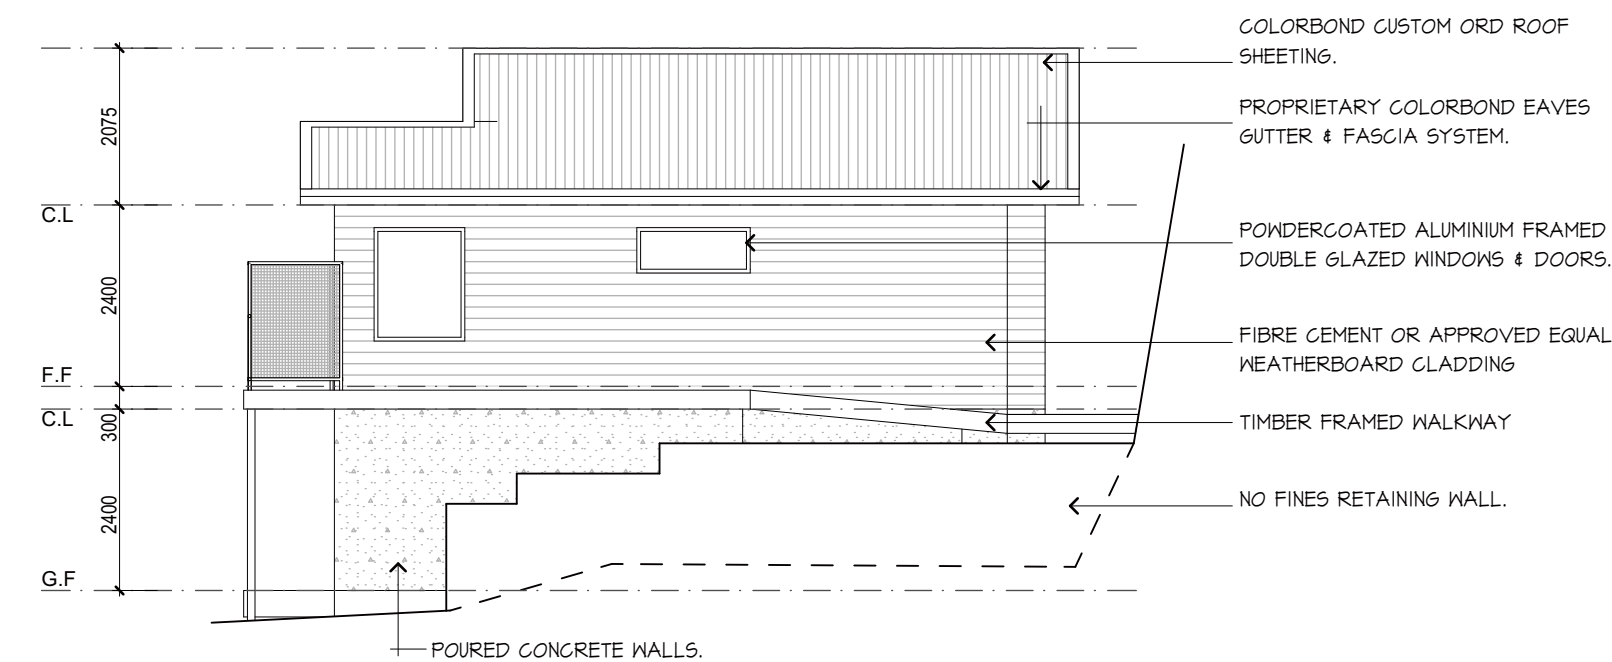
PROPOSED WEST ELEVATION
SCALE 1:100

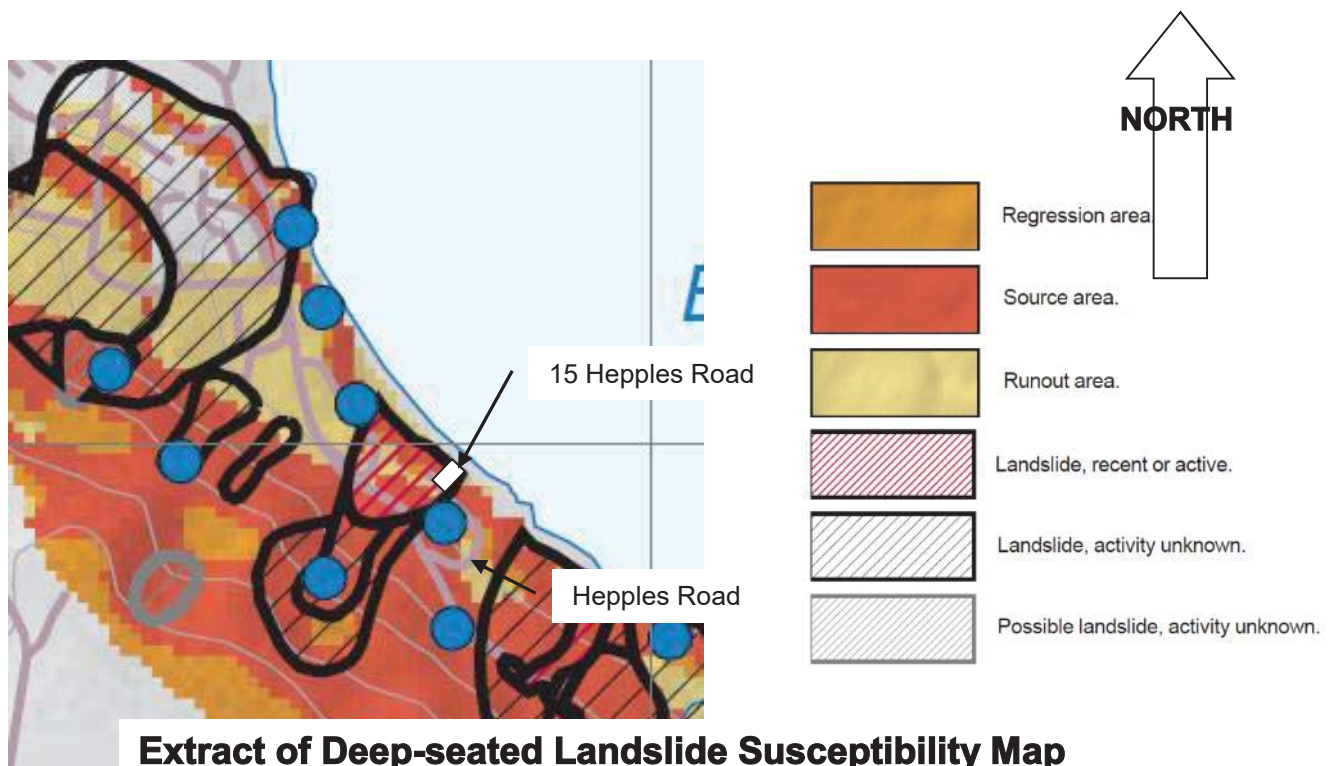
drawn	WG	 	client:	6ty°	
approved	WG		project:	Landslide Risk Assessment 15 Hepples Road, Boat Harbour	
date	21/1/2019		title:	MRT Landslide Susceptibility Map Extracts	
scale	NTS		project no:	TG17185/1 – 02report	figure no: FIGURE 5
original size	A4

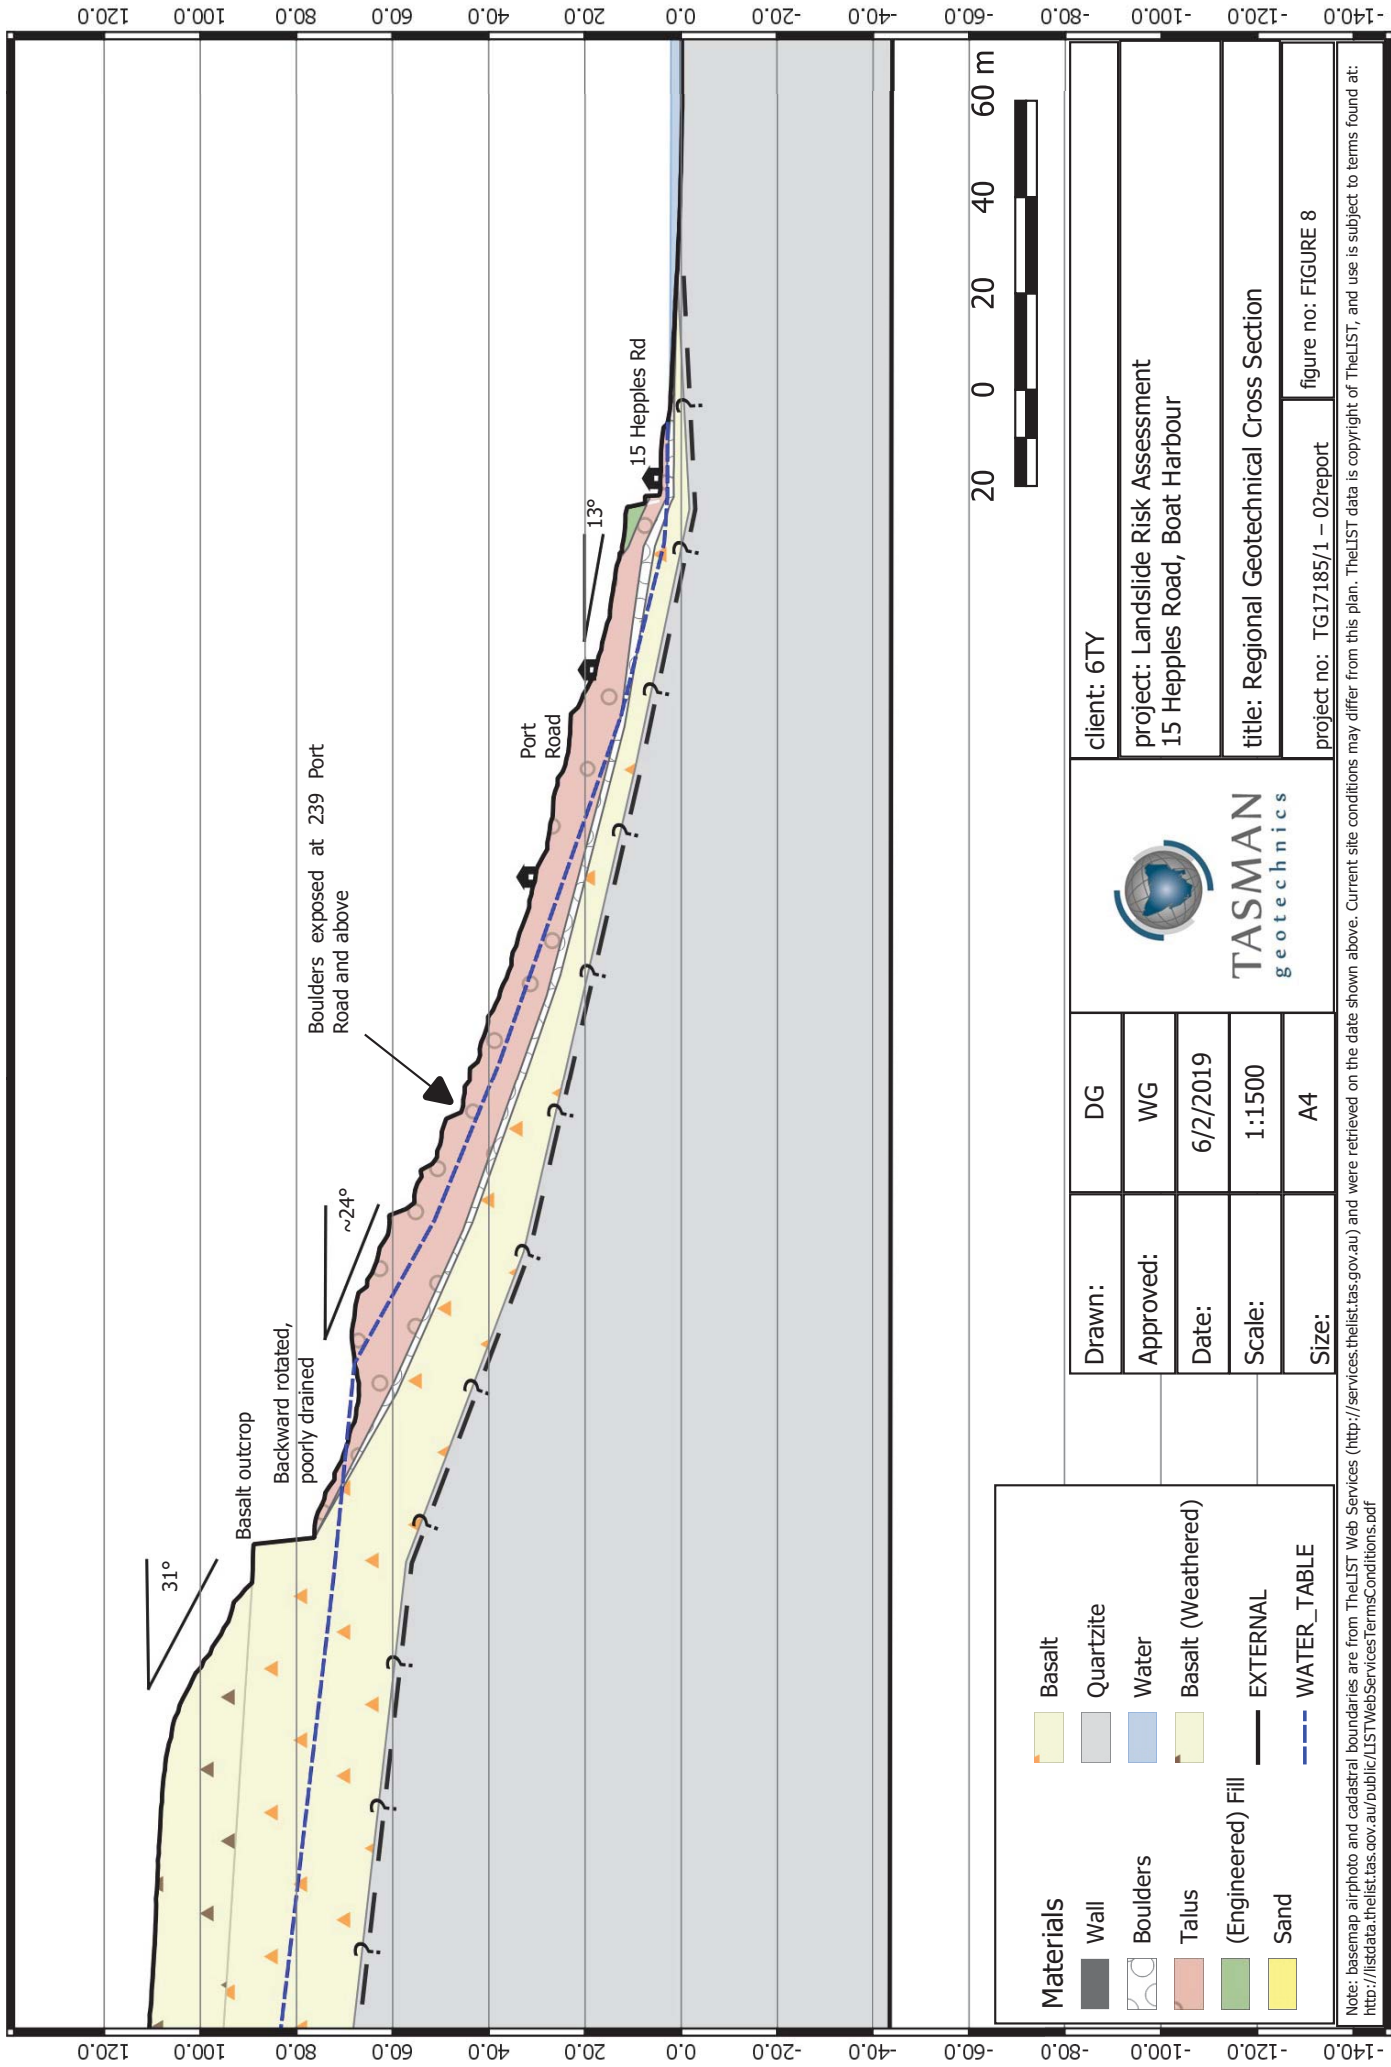
client: 6TY		project: Landslide Risk Assessment 15 Hepples Road, Boat Harbour	
title: Regional Geotechnical Cross Section		project no: TG17185/1 – 02report	
figure no: FIGURE 8

Materials	Basalt
Wall	Quartzite
Boulders	Water
Talus	Basalt (Weathered)
(Engineered) Fill	EXTERNAL
Sand	WATER_TABLE

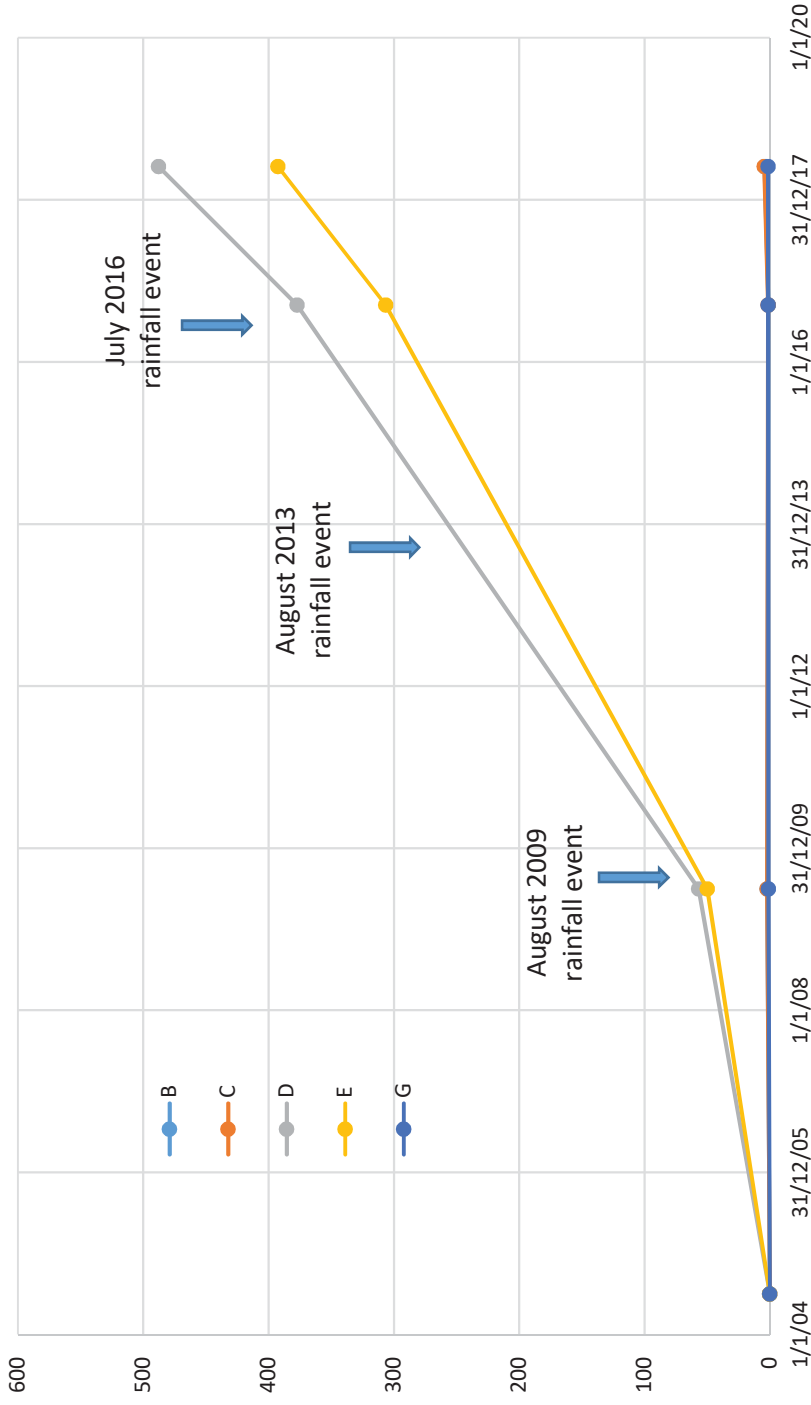
Point	1/07/2004	1/07/2009	14/09/2016	31/05/2018
B	0	2.24	1.00	4.24
C	0	2.24	1.41	4.47
D	0	56.80	377.19	487.83
E	0	49.93	306.63	392.59
F	0	0.00	0.00	0.00
G	0	1.00	1.41	1.41

Total movement (mm), Hepples Road

Client	6ty°
Project	Landslide Investigation 15 Hepples Road
Title	Survey Results of Landslide Movement
Project No:	TG17185/1 - 02report
Figure:	Figure B1

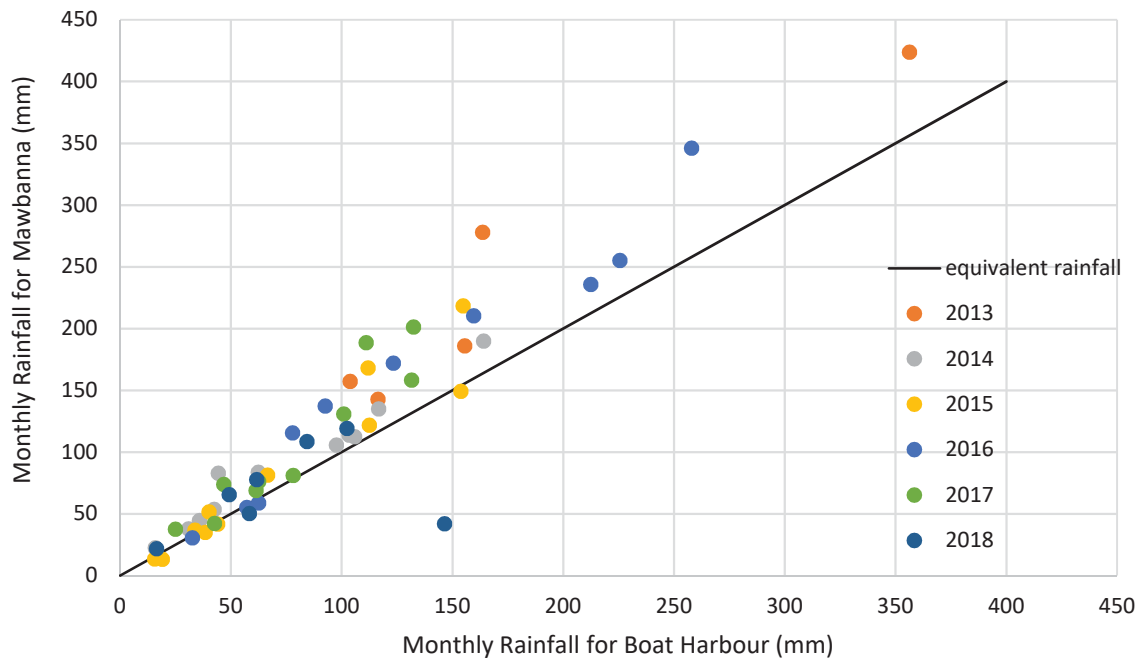
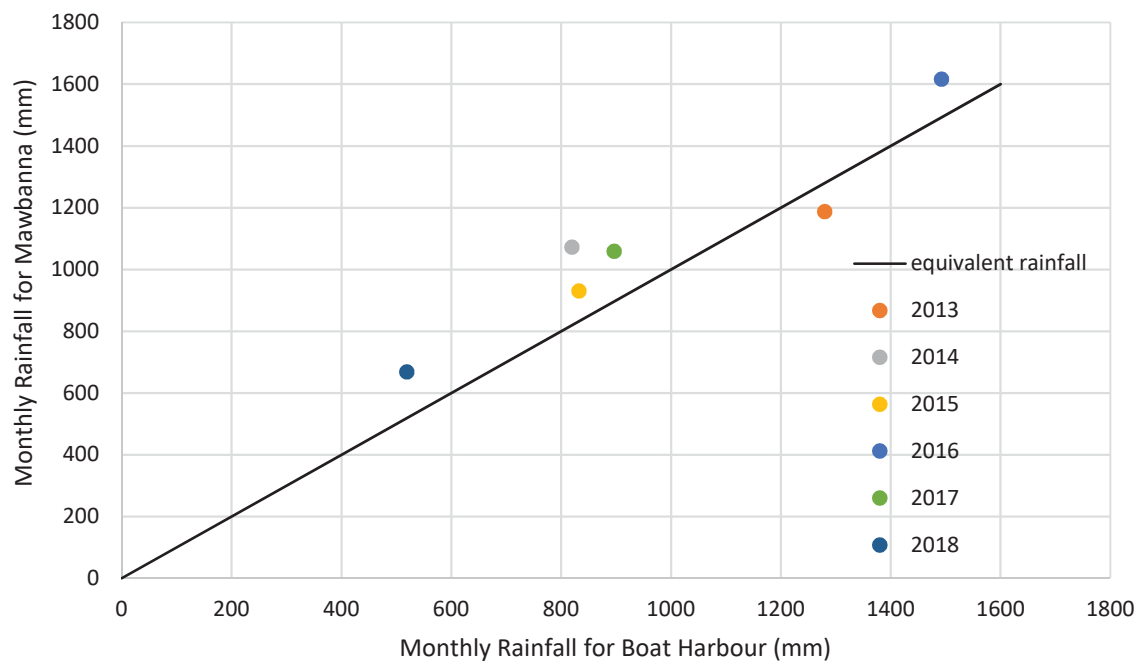
Drawn	WG	 	Client	6ty°	
Approved	WG		Project	Landslide Investigation	
Date	4/02/2019			15 Hepples Road	
Scale	NTS		Title	Rainfall Data Mawbanna and Boat Harbour	
Original size	A4		Project No:	TG17185/1 - 02report	Figure: Figure C1

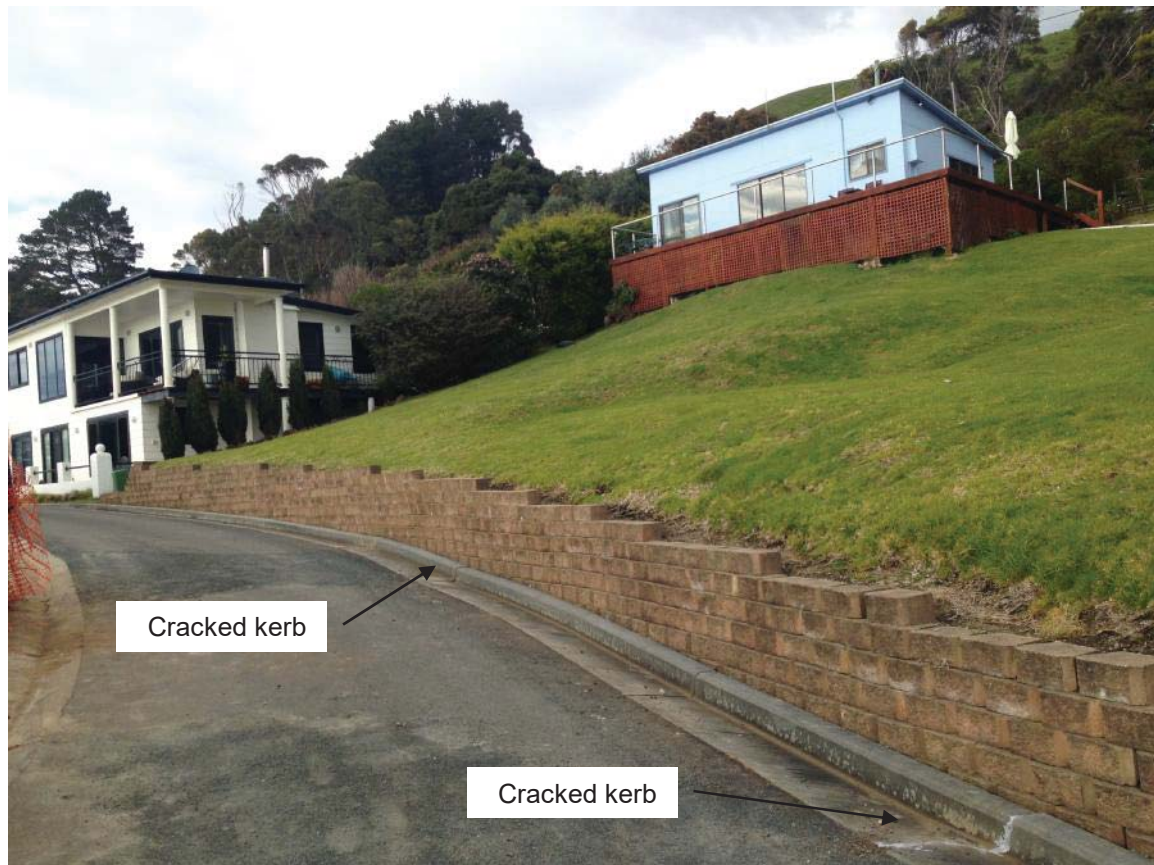
Photo 1. View of Hepples Road showing damage to kerb and hummocky slope above retaining wall (Sept 2016)

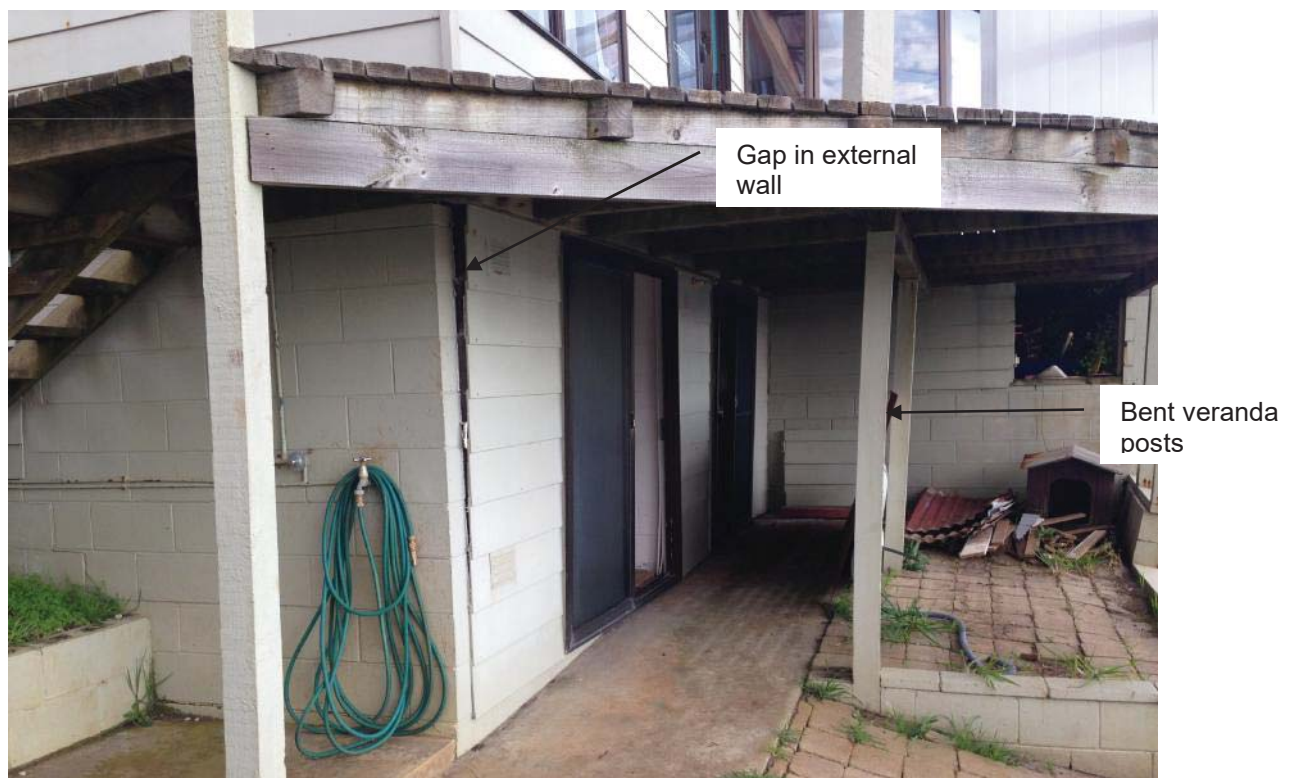
Photo 2. Condition of 15 Hepples Road in Sept 2016

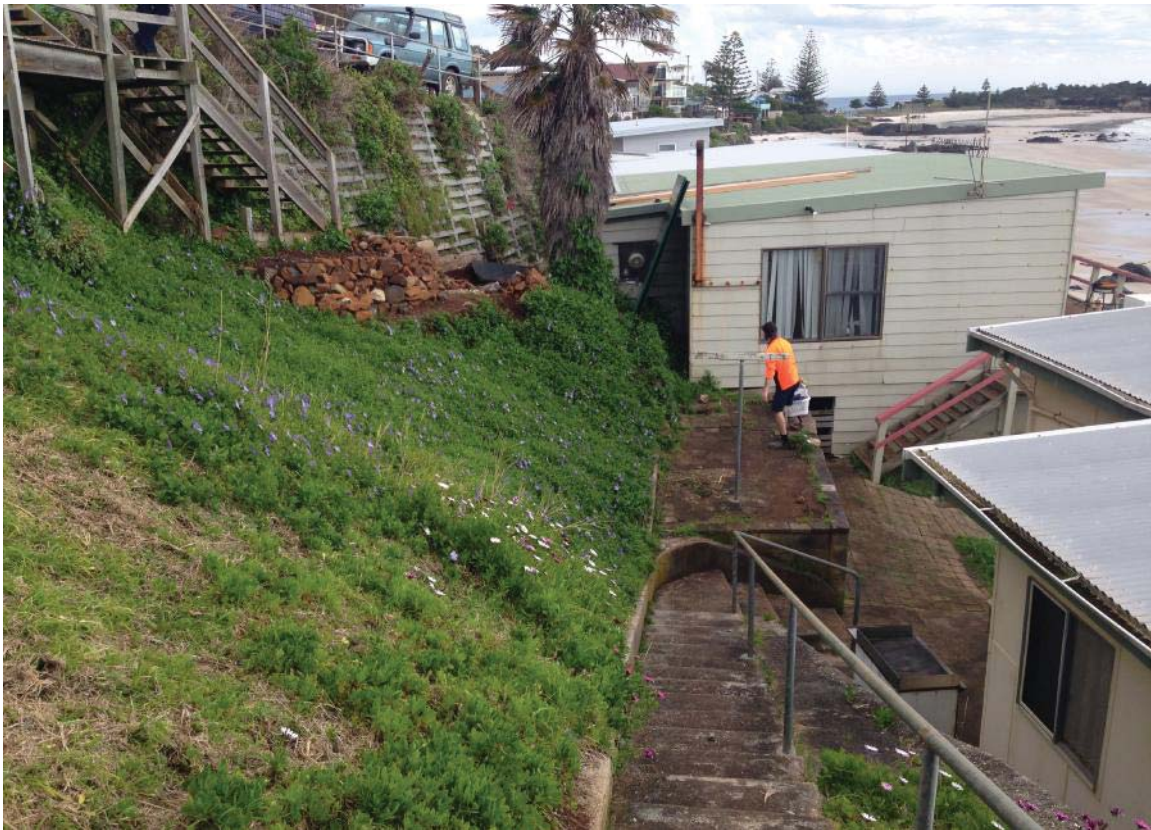
Photo 3. View of crib wall behind 15 Hepples Road (Sept 2016)

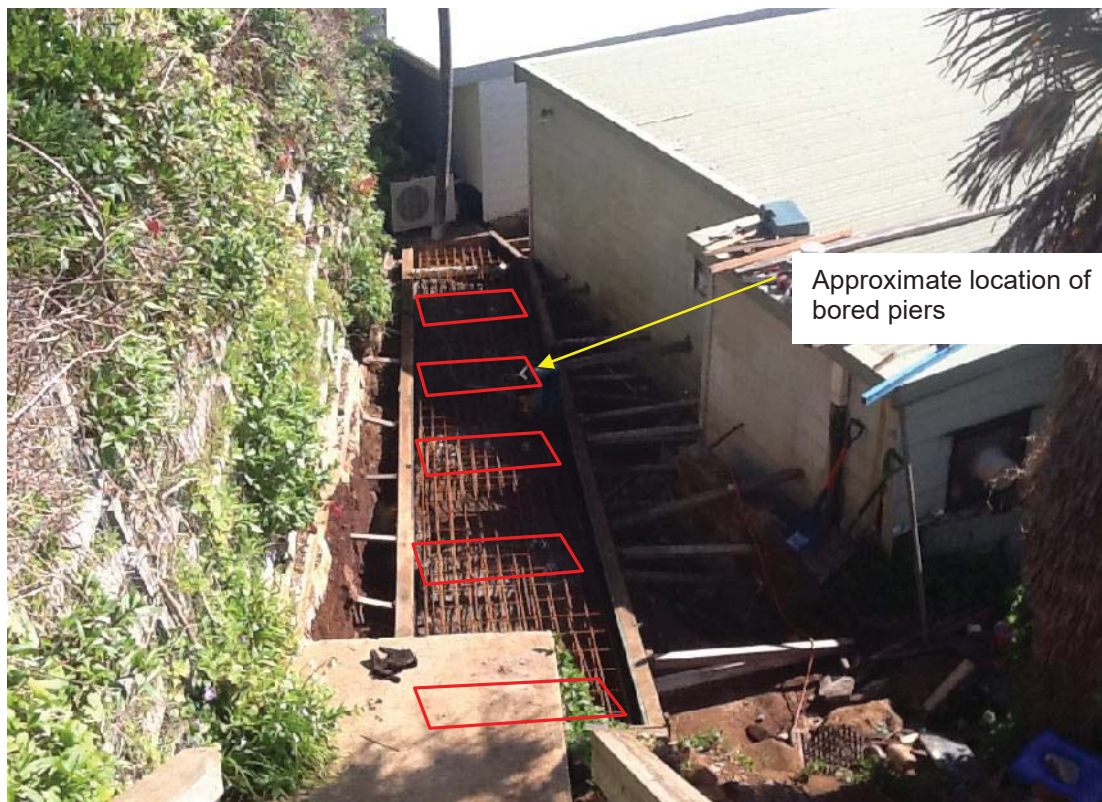
Photo 4. Formwork for strip footing joining bored piers at base of crib wall (image supplied by 6ty°)

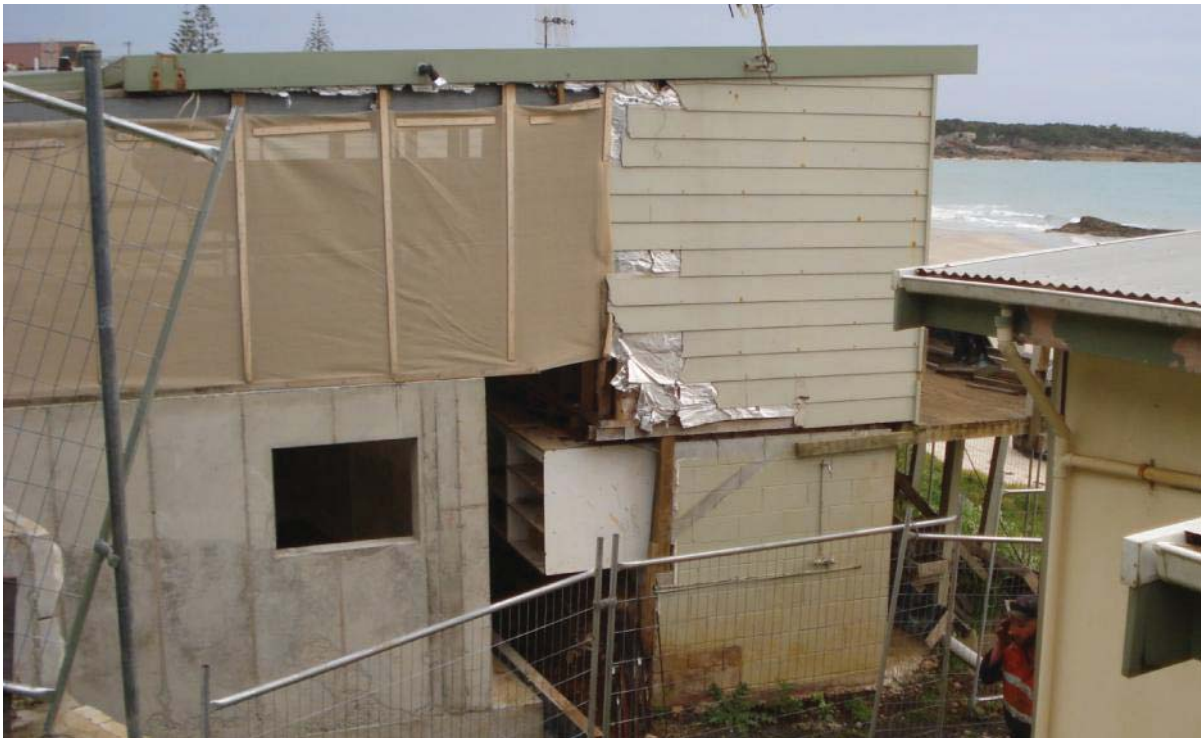
Photo 6. Detail of new construction and old building (sept 2017)

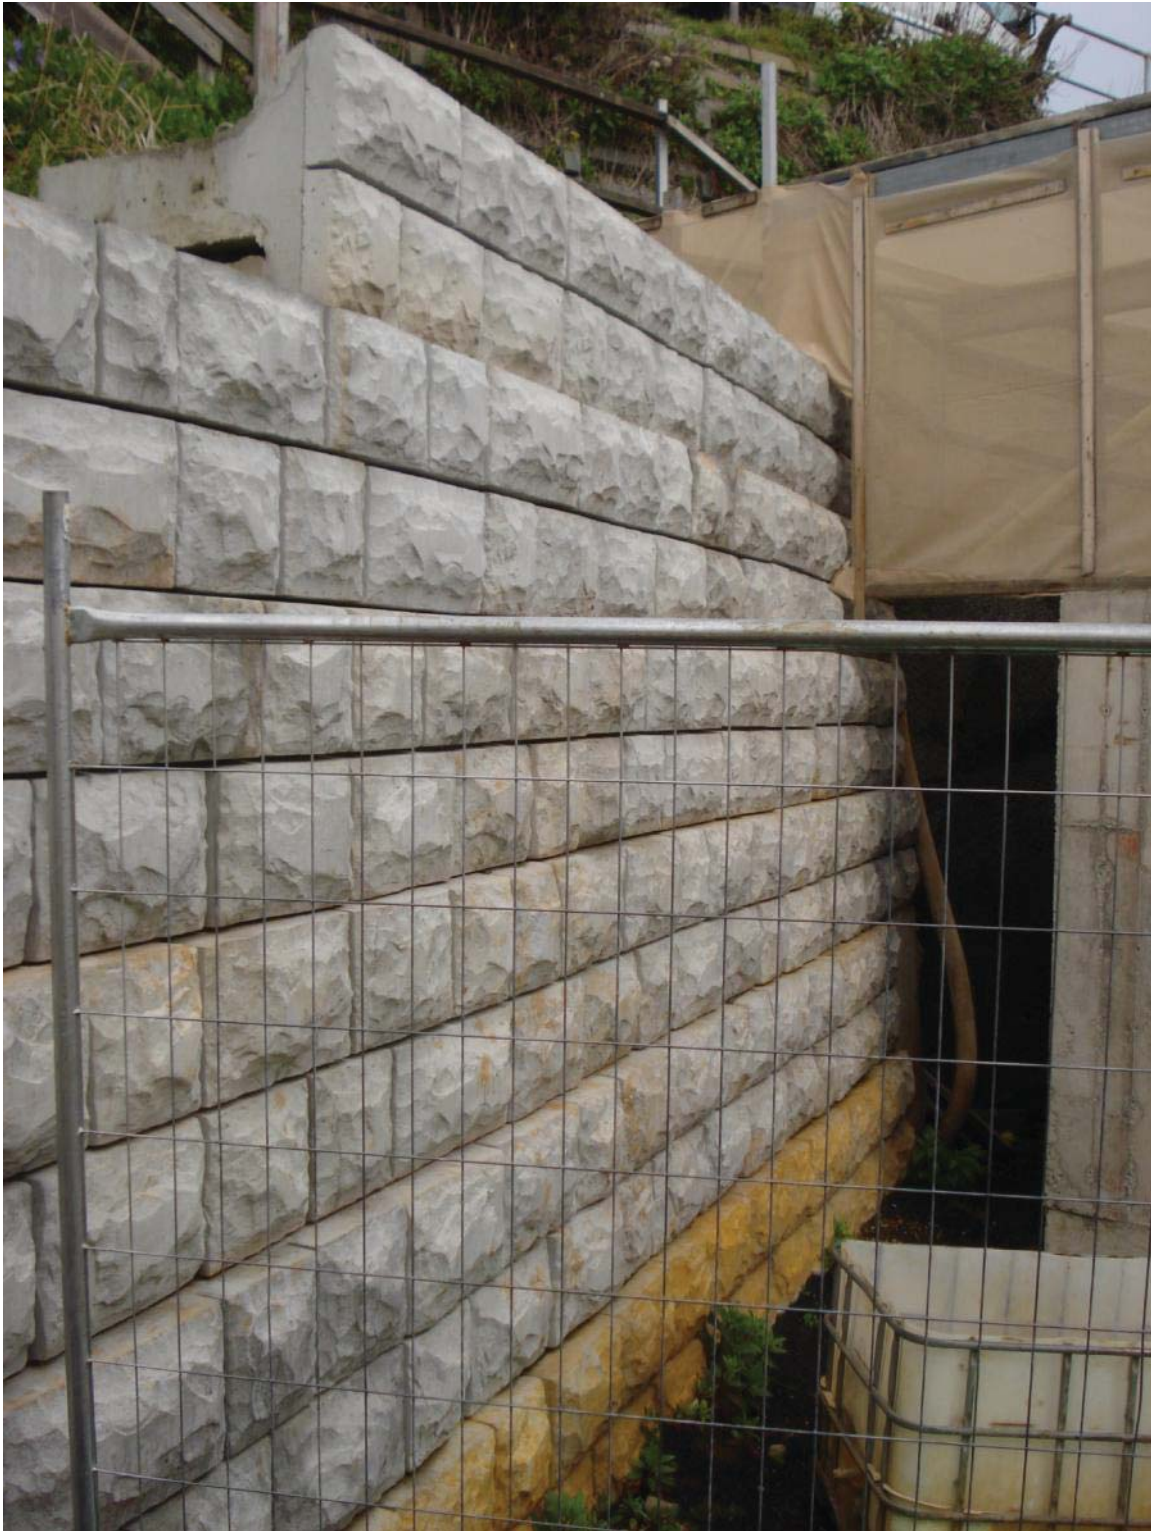
Photo 7. Verti-block wall at rear of new construction (sept 2017). Note crib wall above verti-blocks
