PLANNING PERMIT APPLICATION
APPLICATION FOR PLANNING APPROVAL UNDER SECTION 51,
LAND USE PLANNING & APPROVALS ACT 1993

Demolition of existing dwelling, replacement dwelling and construction of retaining walls.

**ADDITIONAL INFORMATION REQUIRED
DEVELOPMENT APPLICATION – Demolition of existing dwelling,
replacement dwelling and retaining walls
15 Hepples Road and 13 Hepples Road BOAT HARBOUR BEACH**

Planning approval is sought to demolish an existing dwelling and construct a new dwelling and retaining walls on land located at 13 and 15 Hepples Road, Boat Harbour (the site - refer to Figure 1). This planning submission provides relevant details of the application and an assessment against the applicable provisions of the Waratah-Wynyard Interim Planning Scheme 2013 (the Scheme).

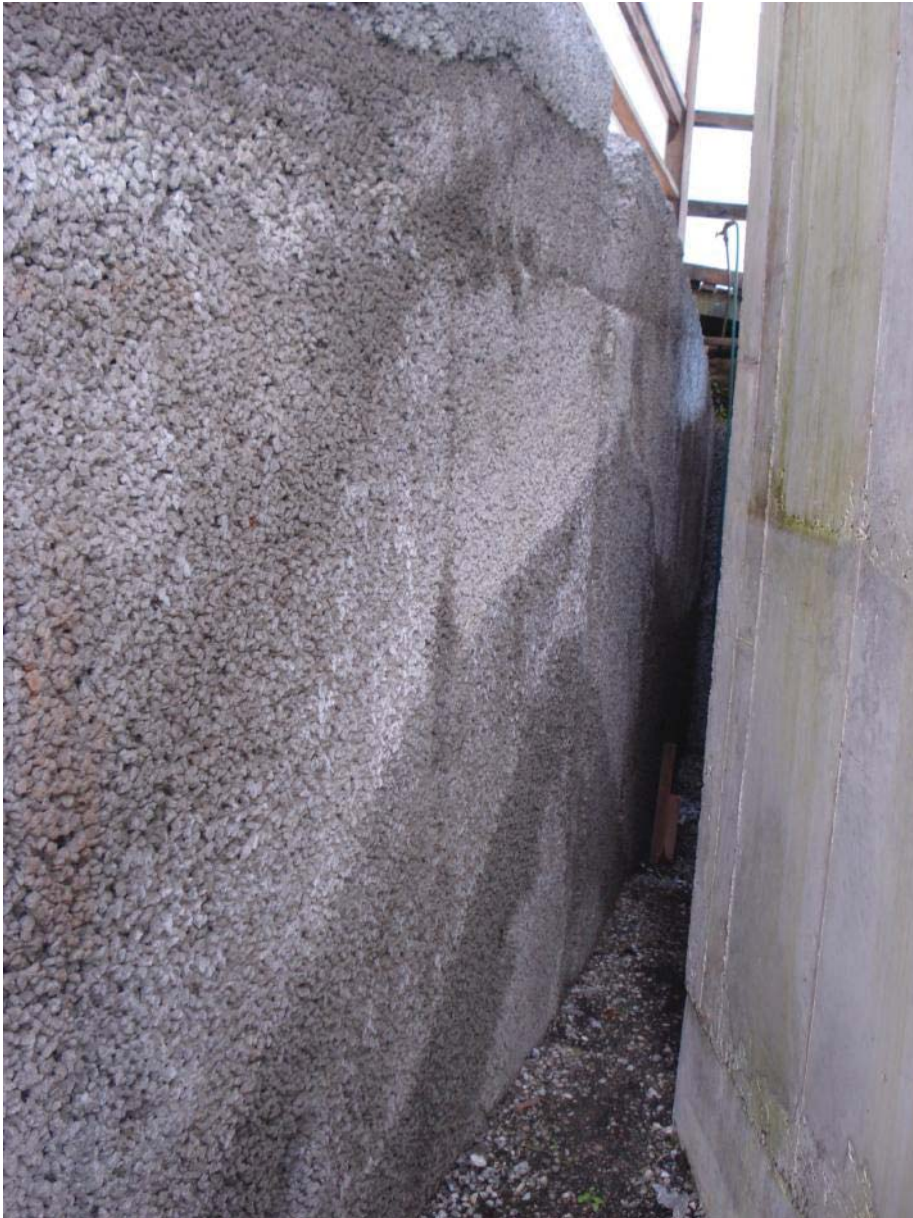
Photo 8. New no-fines concrete retaining wall (Sept 2017)

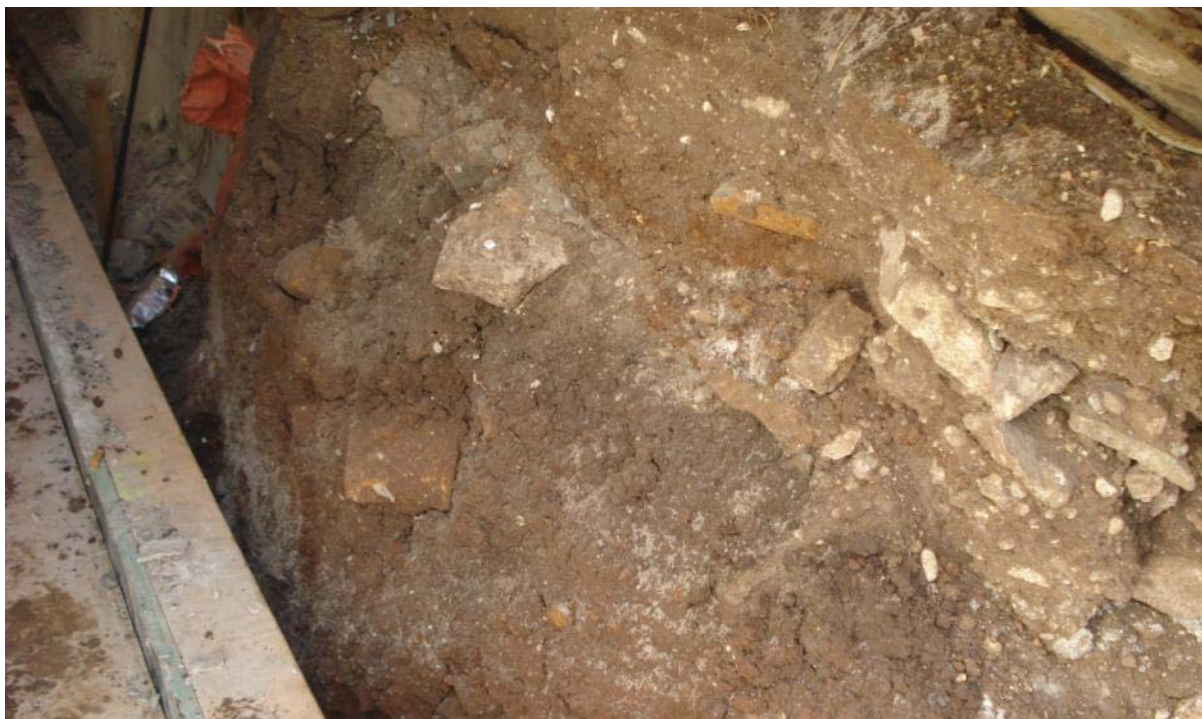
Photo 10. Cut face showing talus (Sept 2017)

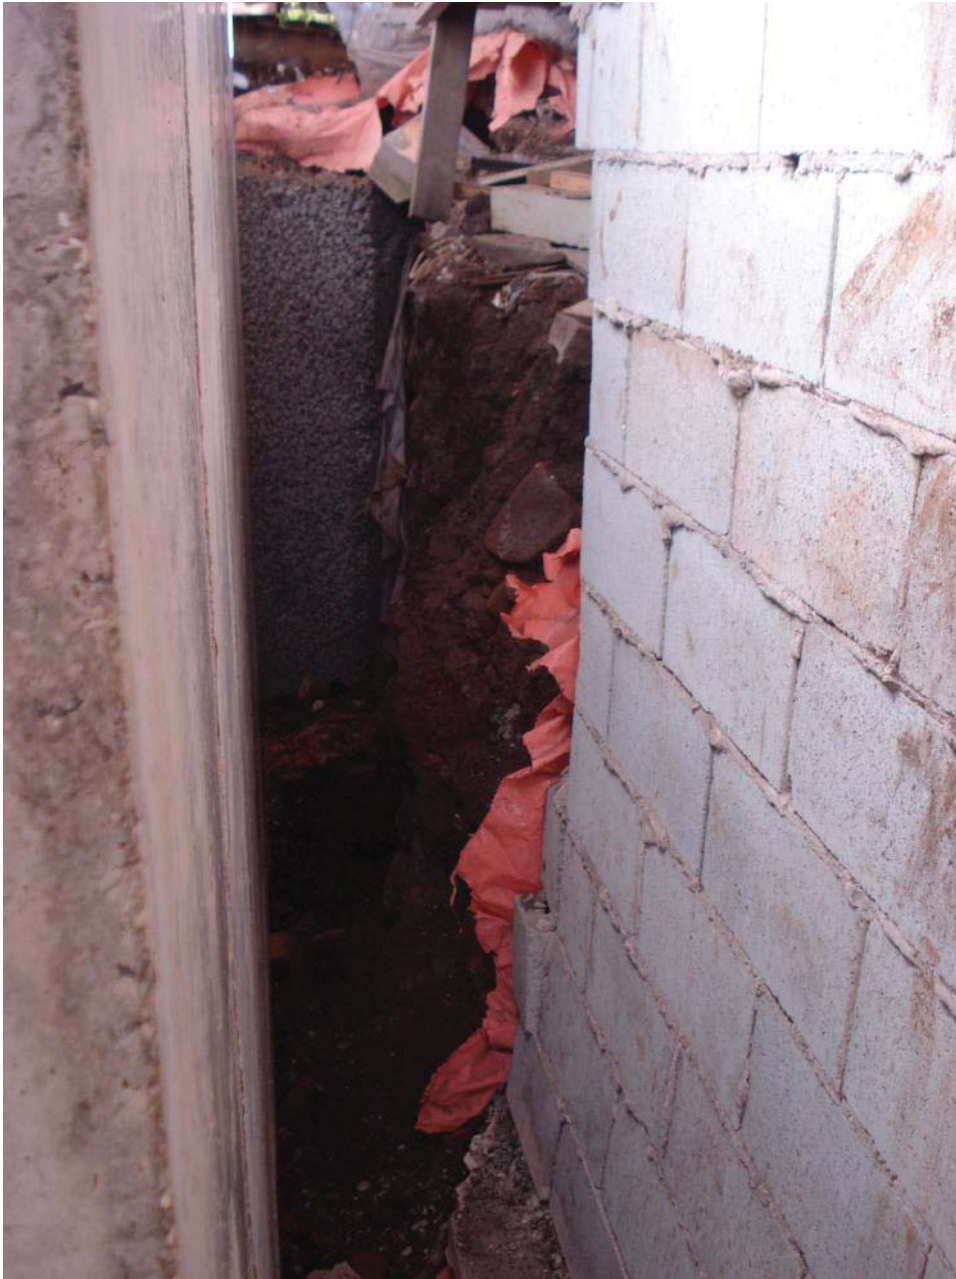
Photo 11. Original (deformed) wall of lower level (Sept 2017)

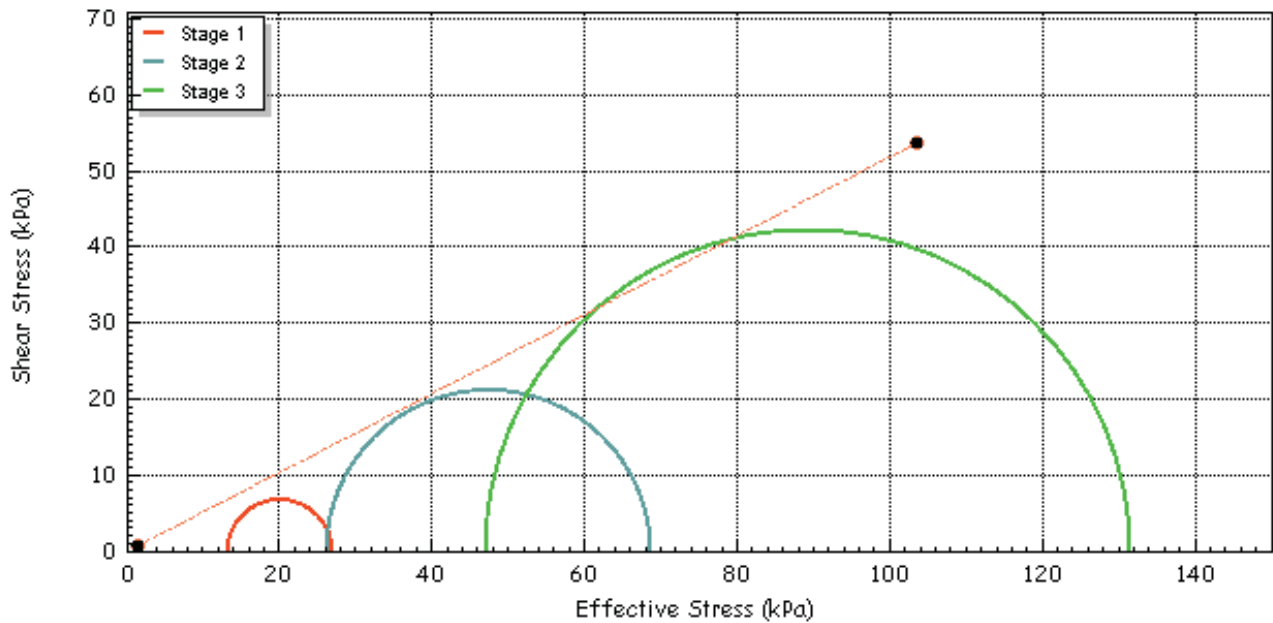
Effective Cohesion	c'	(kPa)	0.00
Effective Friction	ϕ'	(deg)	27.4

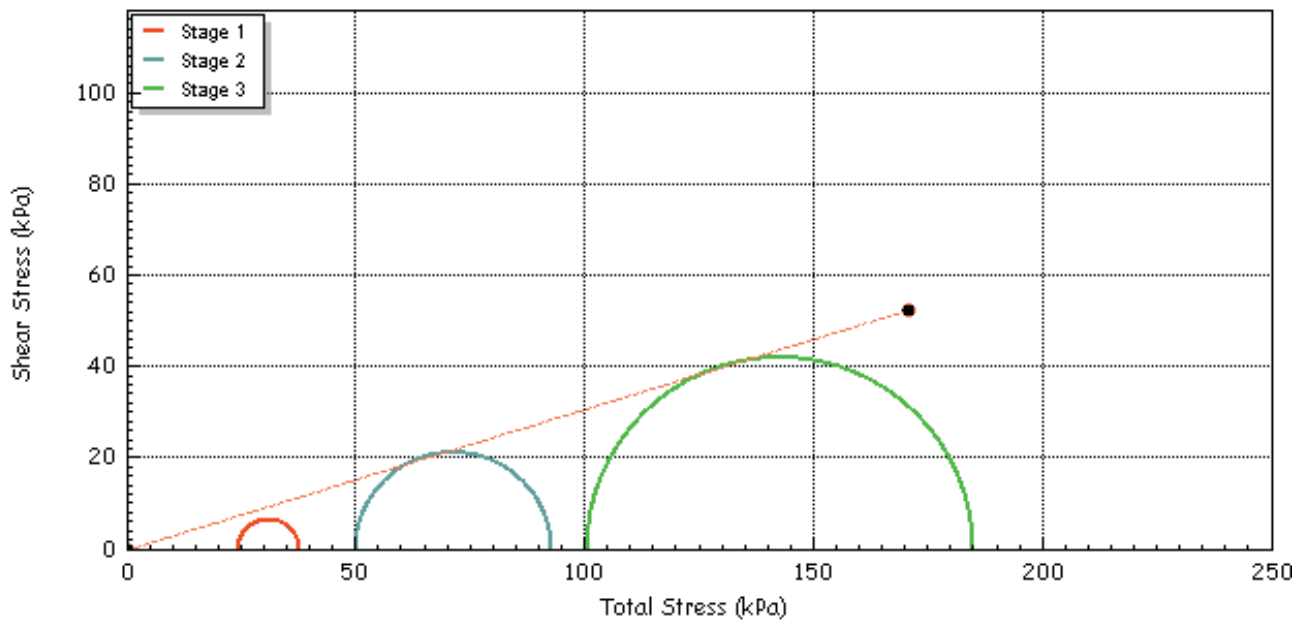
Total Cohesion	c	(kPa)	0.00
Total Friction Angle	ϕ	(deg)	17.0

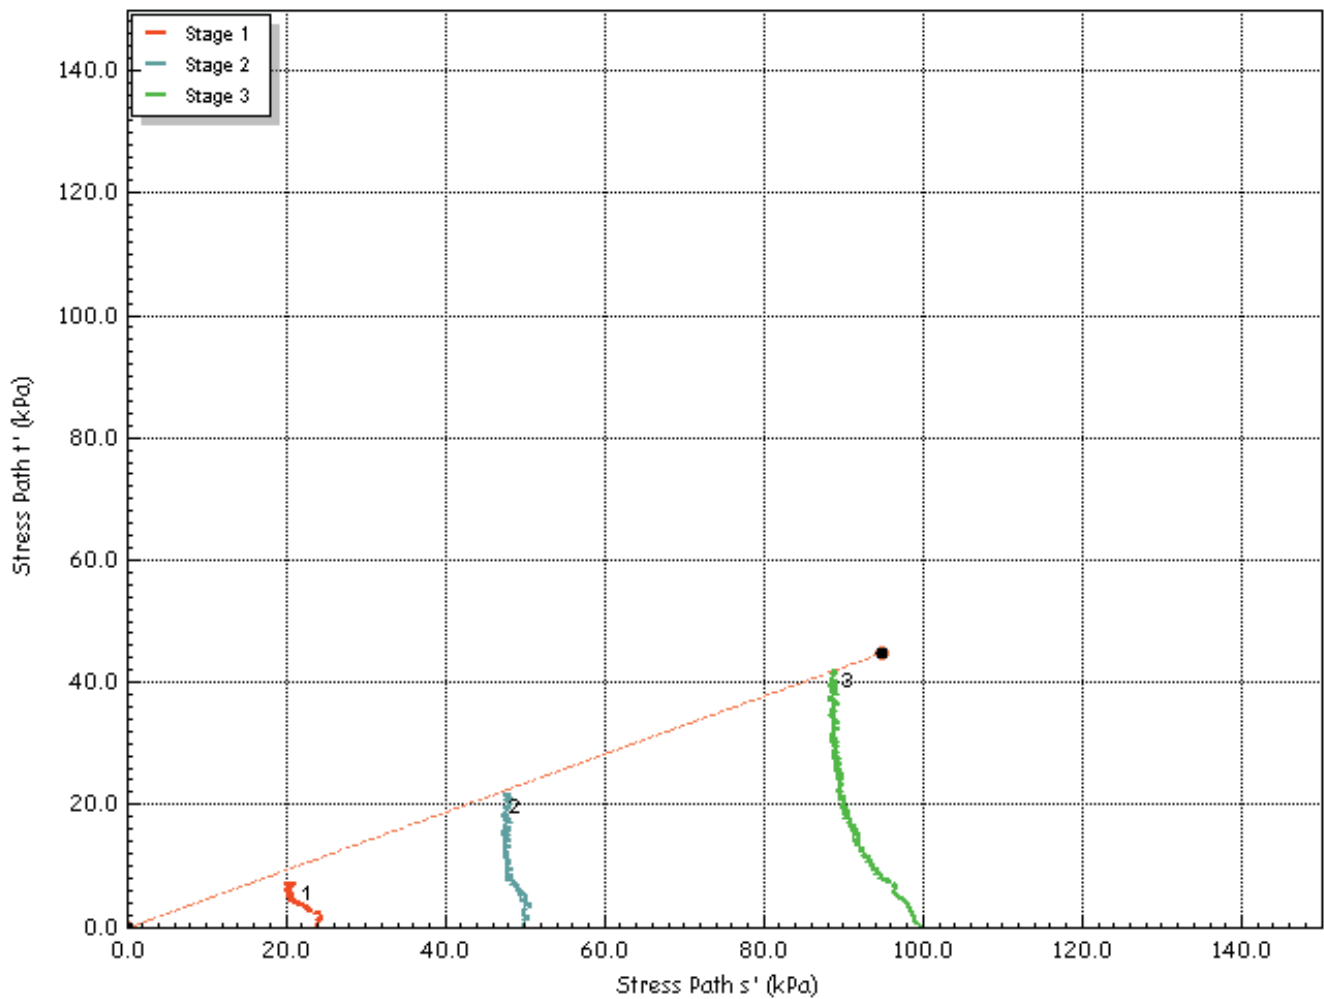
Effective Cohesion	c'	(kPa)	0.00
Effective Friction Angle	ϕ'	(deg)	28.2
Stress Path Intercept	t_0'	(kPa)	0.00
Stress Path Inclination	θ	(deg)	25.3
